**Flood Control Project Maintenance
Levee Inspections**
LMA District Cover Sheet
Spring 2018 Levee Inspection Results

Reclamation District No. 2031 Elliot

Waterway			Bank	Unit Miles
Unit No. 01 Stanislaus River			Left	7.07
	Spring (March - May)	Summer (June - August)	(September - November) Fall	Winter (December - February)
Unit Maintenance Rating (Fall Only)				
Date of Inspection	5/16/2018 - 5/16/2018			
DWR Inspector	Sterling York			
Accompanied By	Arvid Carlson RD2031

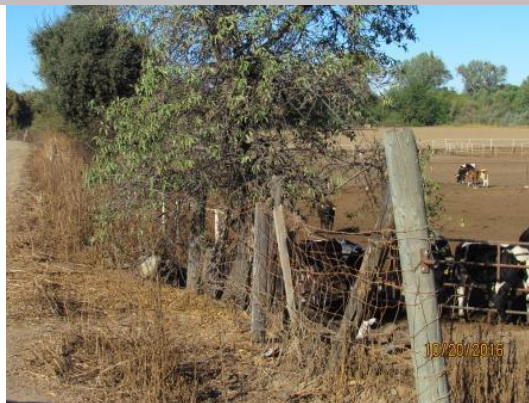
Photo 1 of 2 : SP_2018_RD2031_307_963_20180515_00043.jpg

LM Start	0.00	Rating **	M	Issue No.	963
LM End	0.06	Issue Type +	En	Location *	WS
Category	Earthen Levee			GPS Latitude/Longitude	
				Start	End
Item	Encroachments			37.710001 °	37.709951 °
				-121.155391 °	-121.156539 °
DWR ID	DWR_RD2031_01_s_2012_963				
Comment Code					
FE : Fence					
Inspector Comment					
Wooden and steel livestock fence and debris limit access to slope.

View of the fence on the waterside levee slope. Fall 2016

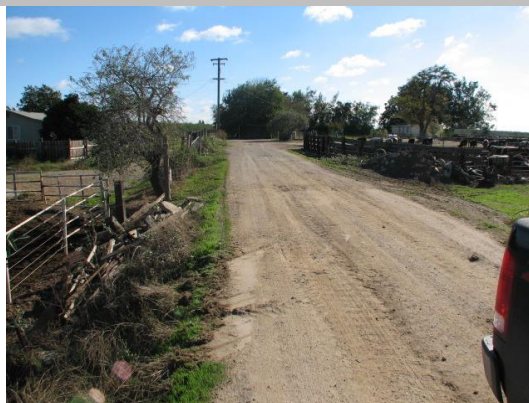
Photo 2 of 2 : SP_2018_RD2031_307_963_20180515_00044.jpg

Fall 2009 photo looking upstream at beginning of unit 1. Water side to the left.

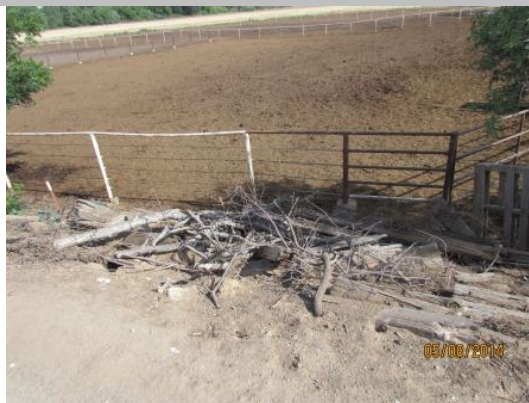
Photo 1 of 1 : SP_2018_RD2031_307_122_20180515_00040.jpg

LM Start	0.02	Rating **	U	Issue No.	122
LM End	0.02	Issue Type +	En	Location *	WS
Category	Earthen Levee			GPS Latitude/Longitude	
				Start	End
Item	Encroachments			37.710016 °	37.710016 °
				-121.155803 °	-121.155803 °
DWR ID	DWR_RD2031_01_s_2015_122				
Comment Code					
DE : Debris					
Inspector Comment

View of the pile of debris on the waterside levee slope.

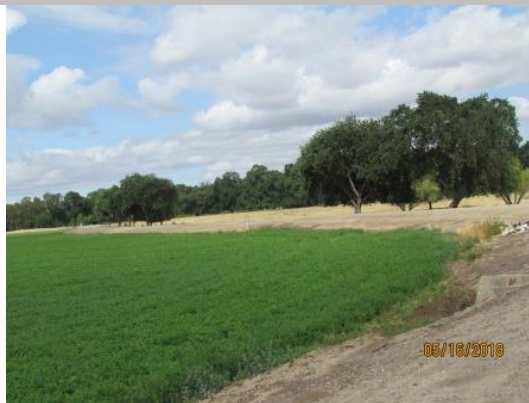
Photo 1 of 1 : SP_2018_RD2031_307_34_20180517_00105.jpg

LM Start	0.03	Rating **	A	Issue No.	34
LM End	7.07	Issue Type +	Ma	Location *	LS
Category	Earthen Levee			GPS Latitude/Longitude	
				Start	End
Item	Vegetation			37.709990 °	37.661853 °
				-121.155869 °	-121.232863 °
DWR ID	DWR_RD2031_01_s_2018_34				
Comment Code					
V1 : Control annual grass and weeds on the levee slopes and easements.					
Inspector Comment

View looking downstream landside of the well maintained annual vegetation.

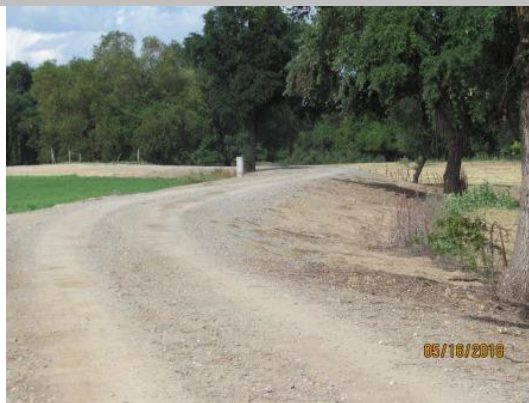
Photo 1 of 1 : SP_2018_RD2031_307_38_20180517_00106.jpg

LM Start	0.03	Rating **	A	Issue No.	38
LM End	1.95	Issue Type +	Ma	Location *	WS
Category	Earthen Levee			GPS Latitude/Longitude	
				Start	End
Item	Vegetation			37.709990 °	37.694491 °
				-121.155870 °	-121.177521 °
DWR ID	DWR_RD2031_01_s_2018_38				
Comment Code					
V1 : Control annual grass and weeds on the levee slopes and easements.					
Inspector Comment

View looking downstream waterside of the well maintained annual vegetation.

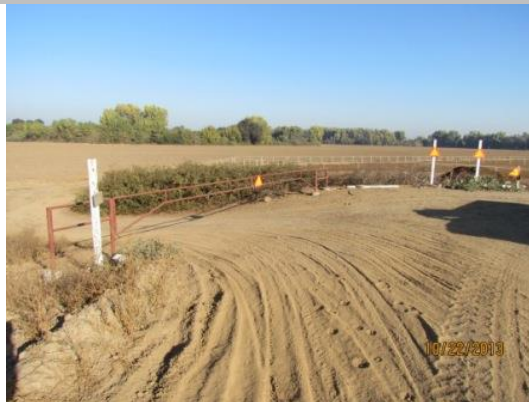
Photo 1 of 1 : SP_2018_RD2031_307_50_20180515_00029.jpg

LM Start	0.06	Rating **	M	Issue No.	50
LM End	0.06	Issue Type +	En	Location *	WS
Category	Earthen Levee			GPS Latitude/Longitude	
				Start	End
Item	Encroachments			37.709950 °	37.709950 °
				-121.156540 °	-121.156540 °
DWR ID	DWR_RD2031_01_f_2013_50				
Comment Code					
FE : Fence					
Inspector Comment					
Unpermitted gates at waterside levee hinge.

View of the gate at the waterside levee hinge.

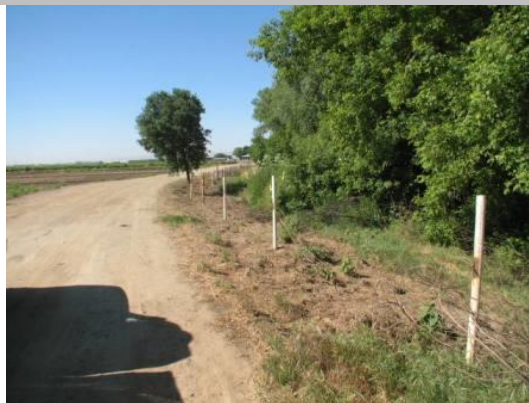
Photo 1 of 3 : SP_2018_RD2031_307_7_20180515_00004.jpg

05/10/2011 Fence on waterside prevents access to waterside slope.

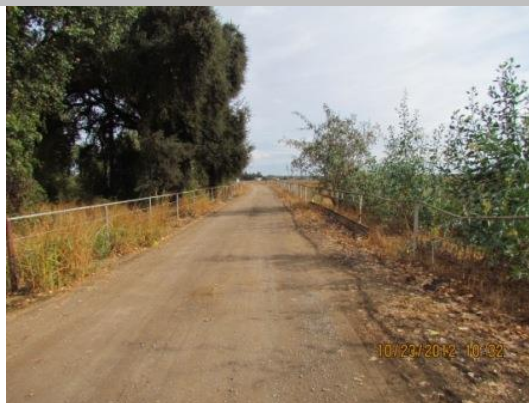
Photo 2 of 3 : SP_2018_RD2031_307_7_20180515_00005.jpg

View of fence obstructing access to waterside slope. Facing upstream.

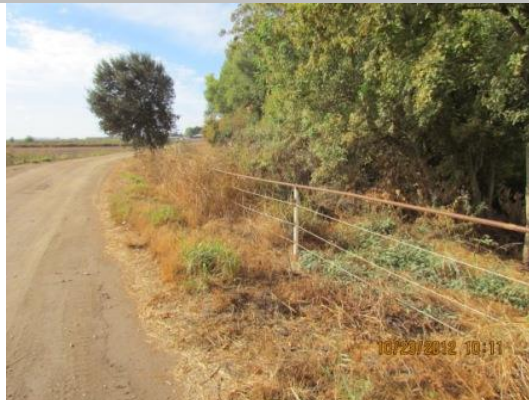
Photo 3 of 3 : SP_2018_RD2031_307_7_20180515_00006.jpg

View of fence on waterside slope facing downstream.

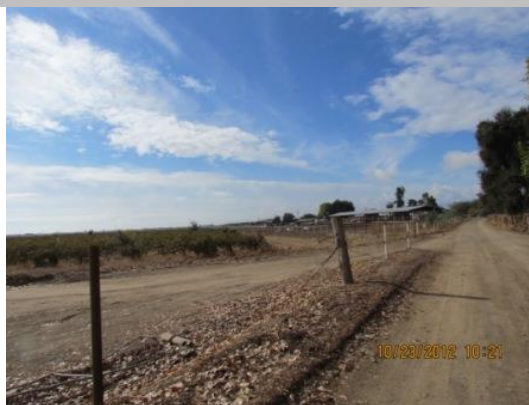
Photo 2 of 2 : SP_2018_RD2031_307_14_20180515_00010.jpg

View of fence on landside levee shoulder facing downstream.

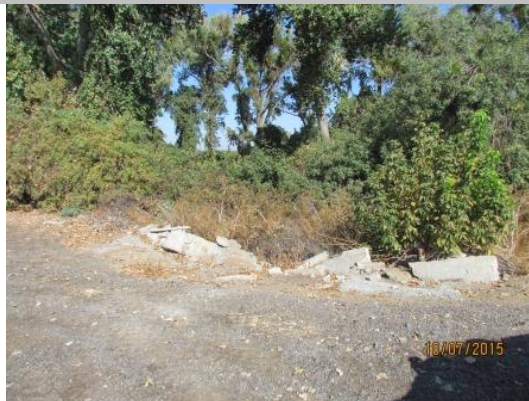
Photo 1 of 1 : SP_2018_RD2031_307_48_20180515_00028.jpg

LM Start	0.51	Rating **	M	Issue No.	48
LM End	0.51	Issue Type +	En	Location *	WS
Category	Earthen Levee			GPS Latitude/Longitude	
				Start	End
Item	Encroachments			37.704041 °	37.704041 °
				-121.159629 °	-121.159629 °
DWR ID	DWR_RD2031_01_f_2015_48				
Comment Code					
MA : Material					
Inspector Comment					
Concrete dumped on the waterside slope.

View of the concrete placed on the waterside levee slope.

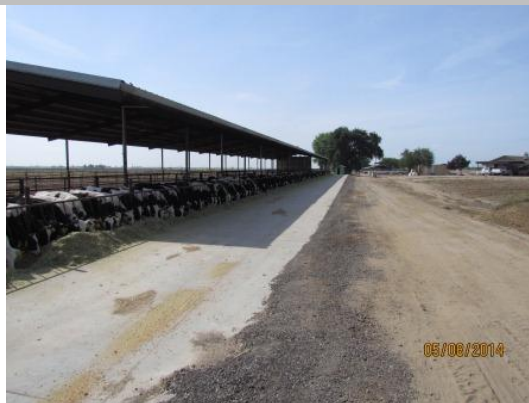
Photo 1 of 1 : SP_2018_RD2031_307_969_20180515_00045.jpg

LM Start	0.54	Rating **	U	Issue No.	969
LM End	0.57	Issue Type +	En	Location *	LS
Category	Earthen Levee			GPS Latitude/Longitude	
				Start	End
Item	Encroachments			37.703626 °	37.703300 °
				-121.159714 °	-121.159779 °
DWR ID	DWR_RD2031_01_s_2012_969				
Comment Code					
BU : Building					
Inspector Comment					
Corrals and house on levee slope and crown. The Corrals do not have CVFPB permit.

View of the new coral at the landside levee slope and toe.

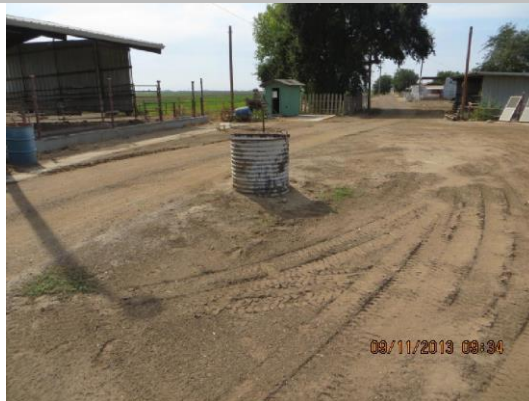
Photo 1 of 3 : UCIP_SP_2018_20044_33942.jpg

LM Start	0.56	Rating **	A/W	Issue No.	984
LM End	0.56	Issue Type +	Ma	Location *	
Category	Supplemental			GPS Latitude/Longitude	
				Start	End
Item	DWR UCIP LMA Responsibility			37.703323 °	37.703323 °
				-121.159771 °	-121.159771 °
DWR ID					
Comment Code					
Inspector Comment					
FS_ID:20044 DS_ID:20439 EP_NO: N/A Repair Type: No Action Needed Crossing Status: Found UCIP Comments: FIELD_STRUCT_DESC: 15-inch corrugated metal drainage pipe through the levee, 9 feet below the crown. Slide gate in a 36-inch corrugated metal pipe (CMP) riser on the waterside (WS) slope. Drainage canal off the landside (LS) toe. This pipe replaced a 15-inch pipe at the same location. [Additional Reference(s): DWR Levee Log, 2005. USACE San Joaquin O&M Manual 4, June 1968, (HLM 0.57)]. FS Date: 9/11/2013

36-inch CMP riser on WS shoulder.

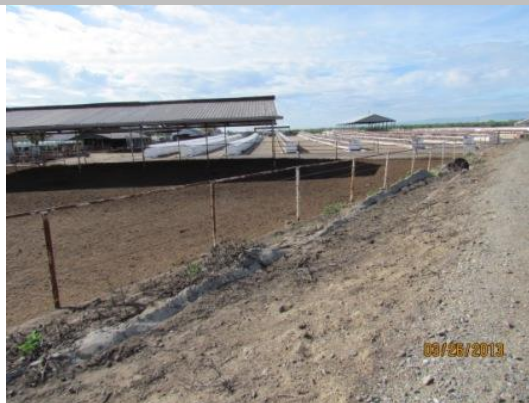
Photo 1 of 1 : SP_2018_RD2031_307_4_20180515_00003.jpg

LM Start	0.63	Rating **	M	Issue No.	4
LM End	0.72	Issue Type +	En	Location *	LS
Category	Earthen Levee			GPS Latitude/Longitude	
				Start	End
Item	Encroachments			37.702814 °	37.701875 °
				-121.160562 °	-121.161670 °
DWR ID	DWR_RD2031_01_s_2012_4				
Comment Code					
FE : Fence					
Inspector Comment

View of the fence at the landside levee toe.

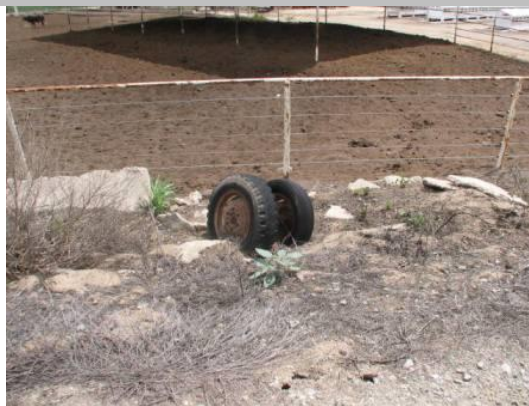
Photo 1 of 1 : SP_2018_RD2031_307_35_20180515_00018.jpg

LM Start	0.65	Rating **	M	Issue No.	35
LM End	0.65	Issue Type +	En	Location *	LS
Category	Earthen Levee			GPS Latitude/Longitude	
				Start	End
Item	Encroachments			37.702643 °	37.702643 °
				-121.160867 °	-121.160867 °
DWR ID	DWR_RD2031_01_s_2012_35				
Comment Code					
DE : Debris					
Inspector Comment					
Tractor wheels on slope of landside levee. It has been there since Spring 2012 inspection.

View of tractor wheels on landward slope. 05/02/2012

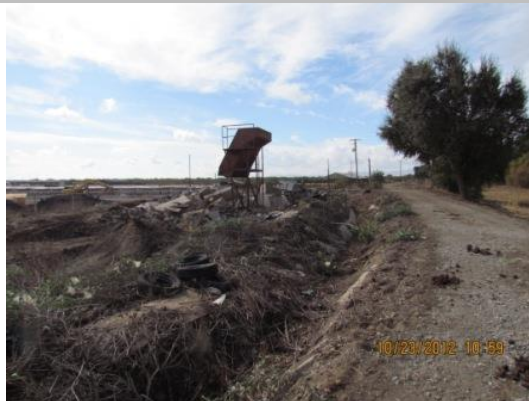
Photo 1 of 1 : SP_2018_RD2031_307_972_20180515_00046.jpg

LM Start	0.72	Rating **	M	Issue No.	972
LM End	0.76	Issue Type +	En	Location *	LS
Category	Earthen Levee			GPS Latitude/Longitude	
				Start	End
Item	Encroachments			37.701906 °	37.701370 °
				-121.161661 °	-121.161986 °
DWR ID	DWR_RD2031_01_s_2012_972				
Comment Code					
DT : Ditch					
Inspector Comment

View of the ditch on landside levee toe, facing downstream.

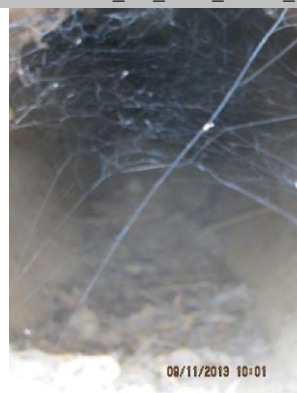
Photo 2 of 3 : UCIP_SP_2018_20049_33955.jpg

LM Start	0.80	Rating **	M	Issue No.	987 (cont)
LM End	0.80	Issue Type +	En	Location *	
Category	Supplemental			GPS Latitude/Longitude	
				Start	End
Item	DWR UCIP Field Study			37.700853 °	37.700853 °
				-121.162349 °	-121.162349 °
DWR ID					
Comment Code					
Inspector Comment					
FS_ID:20049 DS_ID:20443 EP_NO: N/A Repair Type: Non-Urgent Crossing Status: Found UCIP Comments: Pipe appears abandoned as WS slope is covered with soil. If abandoned, it should be done so properly. FIELD_STRUCT_DESC: 24-inch steel irrigation pipe through the levee, 2 feet below the crown. Concrete headwalls on both sides of the levee crown. [Additional Reference(s): DWR Levee Log, 2005. USACE San Joaquin O&M Manual 4, June 1968, (HLM 0.81)]. FS Date: 9/11/2013

Pipe not filled with concrete.

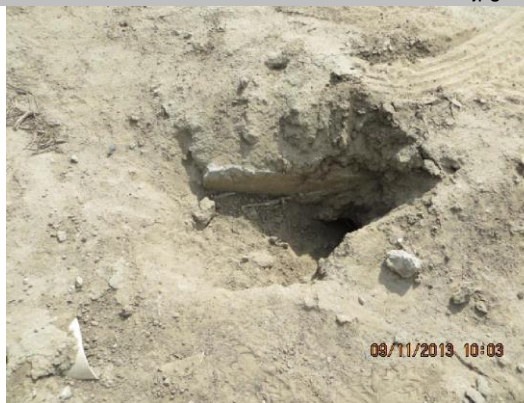
Photo 3 of 3 : UCIP_SP_2018_20049_33954.jpg

Concrete headwall on WS shoulder buried.

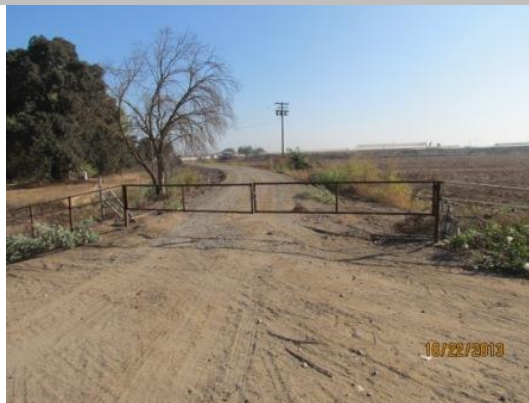
Photo 1 of 1 : SP_2018_RD2031_307_51_20180515_00030.jpg

LM Start	0.92	Rating **	M	Issue No.	51
LM End	0.92	Issue Type +	En	Location *	CR
Category	Earthen Levee			GPS Latitude/Longitude	
				Start	End
Item	Encroachments			37.699727 °	37.699727 °
				-121.163919 °	-121.163919 °
DWR ID	DWR_RD2031_01_f_2013_51				
Comment Code					
FE : Fence					
Inspector Comment					
Unpermitted gate across levee crown.

View of the gate across levee crown.

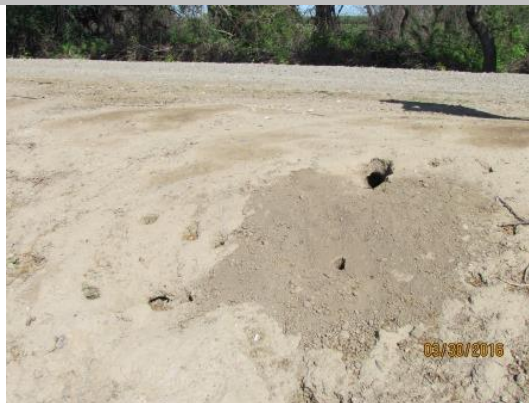
Photo 2 of 3 : SP_2018_RD2031_307_59_20180515_00037.jpg

LM Start	1.00	Rating **	A/W	Issue No.	59 (cont)	
LM End	1.00	Issue Type +	Ma	Location *	LS	
Category	Earthen Levee			GPS Latitude/Longitude		
				Start		End
Item	Animal Control			37.699327 °		37.699327 °
				-121.165364 °		-121.165364 °
DWR ID	DWR_RD2031_01_f_2014_59					
Comment Code						
A3 : No rodents visible, but rodent burrows visible; need to backfill and compact or grout burrows.						
Inspector Comment						
LMA backfilled rodent holes.

Another view of the rodent hole on the landside levee slope.

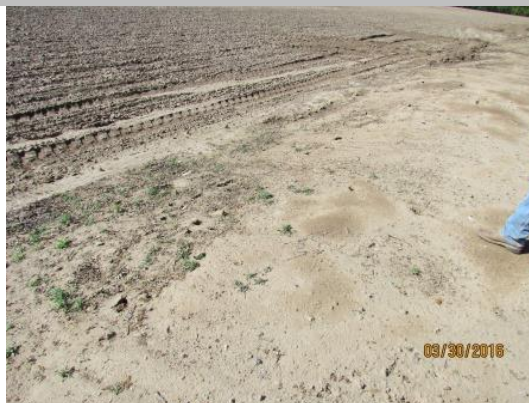
Photo 3 of 3 : SP_2018_RD2031_307_59_20180515_00038.jpg

View of the multiple rodent holes on the landside levee slope.

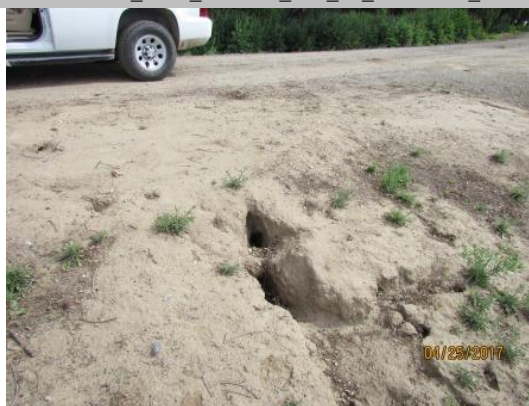
Photo 1 of 2 : SP_2018_RD2031_307_44_20180515_00025.jpg

LM Start	1.16	Rating **	M	Issue No.	44
LM End	1.16	Issue Type +	Ma	Location *	LS
Category	Earthen Levee			GPS Latitude/Longitude	
				Start	End
Item	Animal Control			37.698848 °	37.698848 °
				-121.168088 °	-121.168088 °
DWR ID	DWR_RD2031_01_f_2016_44				
Comment Code					
A3 : No rodents visible, but rodent burrows visible; need to backfill and compact or grout burrows.					
Inspector Comment

View of the rodent holes on the landside levee slope.

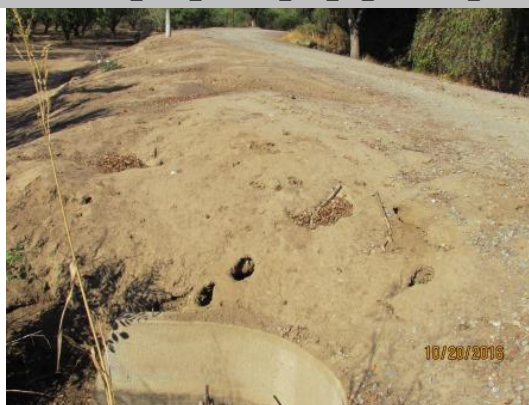
Photo 2 of 2 : SP_2018_RD2031_307_44_20180515_00026.jpg

Another view of the rodent holes on the landside levee slope.

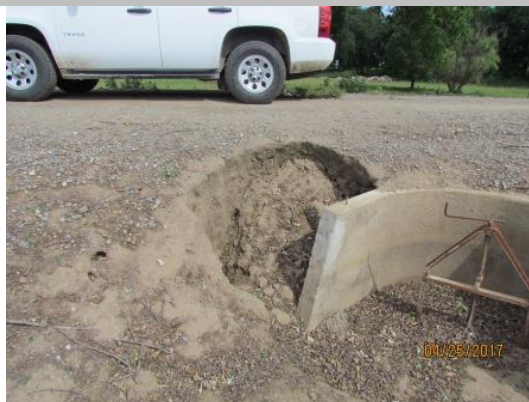
Photo 1 of 1 : SP_2018_RD2031_307_62_20180515_00039.jpg

LM Start	1.41	Rating **	U	Issue No.	62
LM End	1.41	Issue Type +	Ma	Location *	LS
Category	Earthen Levee			GPS Latitude/Longitude	
				Start	End
Item	Erosion / Bank Caving			37.699833 °	37.699833 °
				-121.172060 °	-121.172060 °
DWR ID	DWR_RD2031_01_s_2017_62				
Comment Code					
E2 : Schedule repair of erosion site prior to the next inspection.					
Inspector Comment

View of the erosion on the levee slope penetrating levee prism.

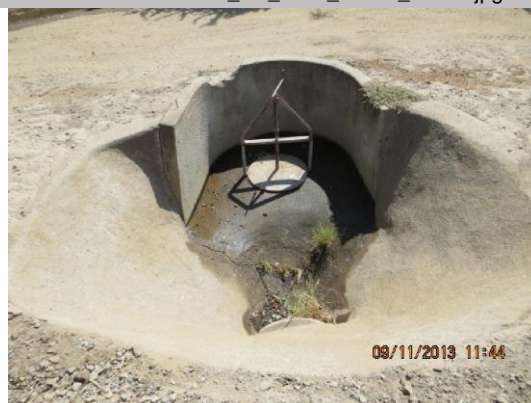
Photo 1 of 3 : UCIP_SP_2018_20088_34030.jpg

LM Start	1.55	Rating **	A/W	Issue No.	990
LM End	1.55	Issue Type +	Ma	Location *	
Category	Supplemental			GPS Latitude/Longitude	
				Start	End
Item	DWR UCIP LMA Responsibility			37.698921 °	37.698921 °
				-121.174144 °	-121.174144 °
DWR ID					
Comment Code					
Inspector Comment					
FS_ID:20088					
DS_ID:20446					
EP_NO: N/A					
Repair Type: No Action Needed					
Crossing Status: Found					
UCIP Comments:					
FIELD_STRUCT_DESC: 24-inch corrugated metal drainage pipe through the levee, 3.5 feet below the crown. Concrete headwalls on both ends. Flap gate on the waterside (WS) end. Installed by USACE in 1966. [Additional Reference(s): DWR Levee Log, 2005. USACE San Joaquin O&M Manual 4, June 1968, (HLM 1.56)].					
FS Date: 9/11/2013

Bowl shaped concrete inlet on LS slope.

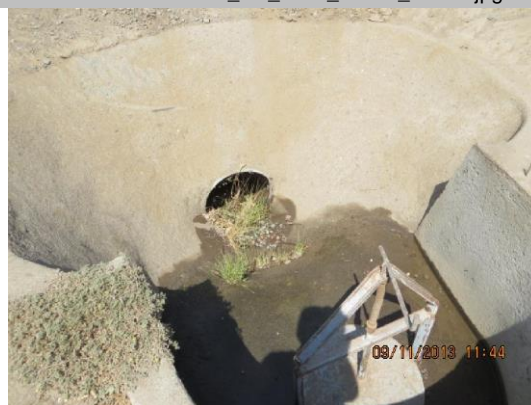
Photo 2 of 3 : UCIP_SP_2018_20088_34029.jpg

Bowl shaped concrete inlet on LS slope.

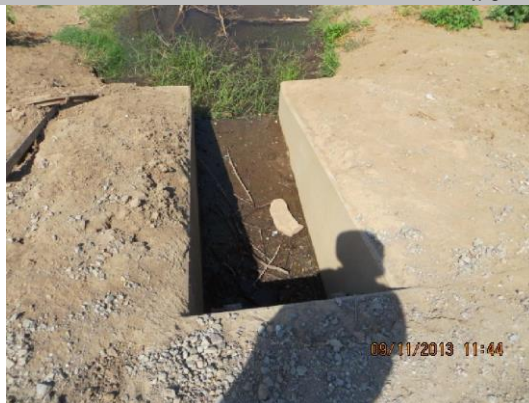
Photo 3 of 3 : UCIP_SP_2018_20088_34028.jpg

LM Start	1.55	Rating **	A/W	Issue No.	990 (cont)
LM End	1.55	Issue Type +	Ma	Location *	
Category	Supplemental			GPS Latitude/Longitude	
				Start	End
Item	DWR UCIP LMA Responsibility			37.698921 °	37.698921 °
				-121.174144 °	-121.174144 °
DWR ID					
Comment Code					
Inspector Comment					
FS_ID:20088					
DS_ID:20446					
EP_NO: N/A					
Repair Type: No Action Needed					
Crossing Status: Found					
UCIP Comments:					
FIELD_STRUCT_DESC: 24-inch corrugated metal drainage pipe through the levee, 3.5 feet below the crown. Concrete headwalls on both ends. Flap gate on the waterside (WS) end. Installed by USACE in 1966. [Additional Reference(s): DWR Levee Log, 2005. USACE San Joaquin O&M Manual 4, June 1968, (HLM 1.56)].					
FS Date: 9/11/2013

Concrete U-shaped headwall on WS slope.

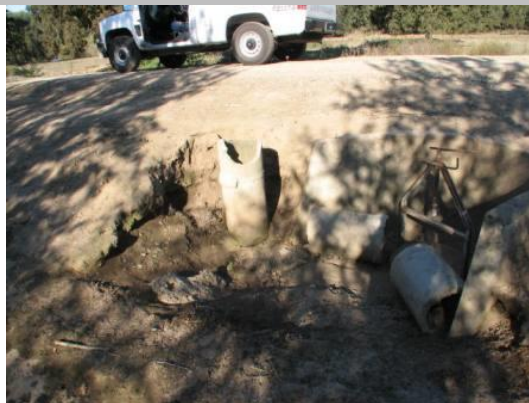
Photo 2 of 2 : SP_2018_RD2031_307_3_20180515_00002.jpg

LM Start	1.56	Rating **	U	Issue No.	3 (cont)	
LM End	1.56	Issue Type +	Ma	Location *	LS	
Category	Earthen Levee			GPS Latitude/Longitude		
				Start		End
Item	Erosion / Bank Caving			37.698776 °		37.698776 °
				-121.174327 °		-121.174327 °
DWR ID	DWR_RD2031_01_s_2012_3					
Comment Code						
E1 : Note and monitor erosion site.						
Inspector Comment						
Erosion is active around the irrigation standpipe.

10/26/2011 Active erosion into the levee prism around irrigation standpipe.

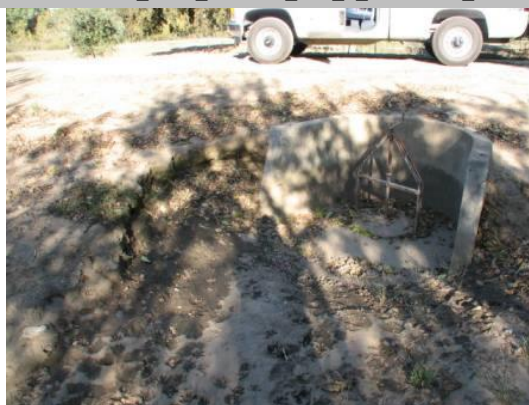
Photo 1 of 1 : SP_2018_RD2031_307_8_20180515_00007.jpg

LM Start	1.58	Rating **	U	Issue No.	8	
LM End	1.58	Issue Type +	Ma	Location *	WS	
Category	Earthen Levee			GPS Latitude/Longitude		
				Start		End
Item	Erosion / Bank Caving			37.698610 °	37.698610 °	
				-121.174598 °	-121.174598 °	
DWR ID	DWR_RD2031_01_s_2012_8					
Comment Code						
E1 : Note and monitor erosion site.						
Inspector Comment						
Active erosion is occurring around irrigation inlet.

10/26/2011 Active erosion shown around irrigation inlet.

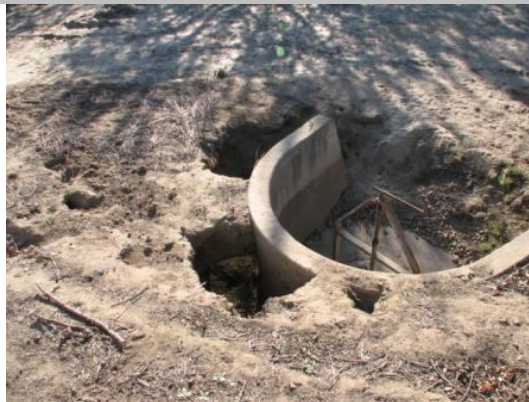
Photo 1 of 1 : SP_2018_RD2031_307_9_20180515_00008.jpg

LM Start	1.63	Rating **	U	Issue No.	9
LM End	1.63	Issue Type +	Ma	Location *	LS
Category	Earthen Levee			GPS Latitude/Longitude	
				Start	End
Item	Erosion / Bank Caving			37.698208 °	37.698208 °
				-121.175400 °	-121.175400 °
DWR ID	DWR_RD2031_01_s_2012_9				
Comment Code					
E1 : Note and monitor erosion site.					
Inspector Comment					
Active erosion around irrigation inlet in levee prism.

10/26/2011 Active erosion into levee prism around irrigation inlet.

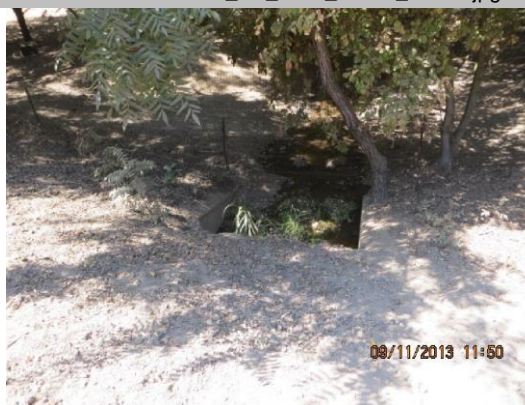
Photo 1 of 3 : UCIP_SP_2018_41354_34034.jpg

LM Start	1.78	Rating **	M	Issue No.	991
LM End	1.78	Issue Type +	Ma	Location *	
Category	Supplemental			GPS Latitude/Longitude	
				Start	End
Item	DWR UCIP LMA Responsibility			37.696958 °	37.696958 °
				-121.177464 °	-121.177464 °
DWR ID					
Comment Code					
Inspector Comment					
FS_ID:41354 DS_ID:20470 EP_NO: N/A Repair Type: Non-Urgent Crossing Status: Found UCIP Comments: Silt buildup at inlet and outlet. FIELD_STRUCT_DESC: 1 of 2: 24-inch corrugated metal drainage pipe through the levee, 9.5 feet below the crown. Concrete U-shaped headwalls on both ends. Flap gate on the waterside (WS) end. Installed by USACE in 1966. [Additional Reference(s): DWR Levee Log, 2005. USACE San Joaquin O&M Manual 4, June 1968, (HLM 1.80)]. FS Date: 9/11/2013

Concrete headwall on WS toe.

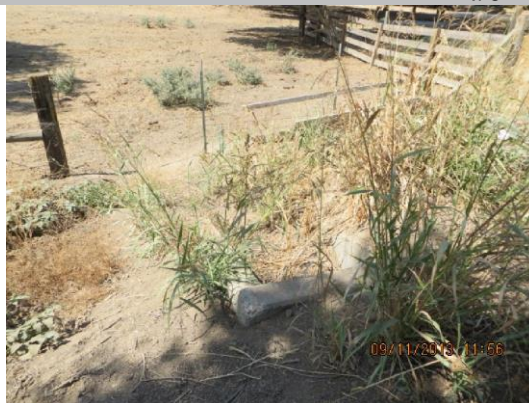
Photo 1 of 3 : UCIP_SP_2018_20109_34075.jpg

LM Start	1.86	Rating **	M	Issue No.	993	
LM End	1.86	Issue Type +	En	Location *		
Category	Supplemental			GPS Latitude/Longitude		
				Start		End
Item	DWR UCIP Field Study			37.695737 °		37.695737 °
				-121.177533 °		-121.177533 °
DWR ID						
Comment Code						
Inspector Comment						
FS_ID:20109 DS_ID:20448 EP_NO: N/A Repair Type: Non-Urgent Crossing Status: Found UCIP Comments: If abandoned it should be done so properly if not, the pipe should be cleared of soil blockage. FIELD_STRUCT_DESC: *ABANDONED* 24-inch drainage pipe of an unknown material through the levee, 6.8 feet below the crown. Concrete headwalls on both ends. Flap gate on the waterside (WS) end. Installed by USACE in 1966. [Additional Reference(s): DWR Levee Log, 2005. USACE San Joaquin O&M Manual 4, June 1968]. FS Date: 9/11/2013

Concrete U-shaped headwall on WS toe.

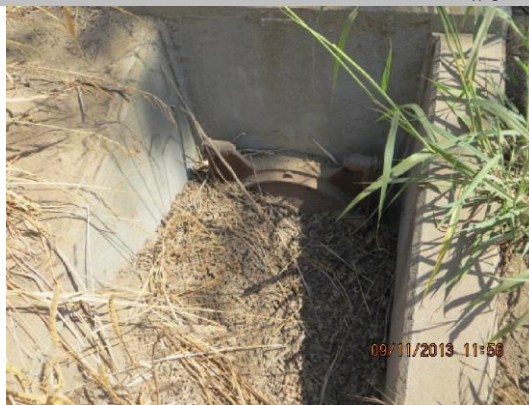
Photo 2 of 3 : UCIP_SP_2018_20109_34074.jpg

Flapgate on WS toe.

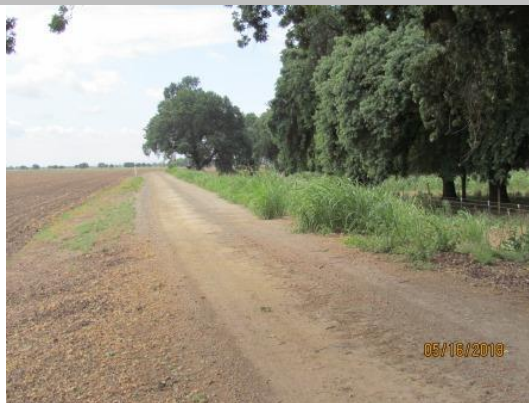
Photo 1 of 1 : SP_2018_RD2031_307_52_20180517_00111.jpg

LM Start	1.95	Rating **	M	Issue No.	52
LM End	2.09	Issue Type +	Ma	Location *	WS
Category	Earthen Levee			GPS Latitude/Longitude	
				Start	End
Item	Vegetation			37.694490 °	37.692495 °
				-121.177521 °	-121.177690 °
DWR ID	DWR_RD2031_01_s_2018_52				
Comment Code					
V1 : Control annual grass and weeds on the levee slopes and easements.					
Inspector Comment					
This section of annual vegetation needs to be maintained, Spring 2018.

View looking downstream waterside of a section where the annual vegetation needs to be maintained, Spring 2018.

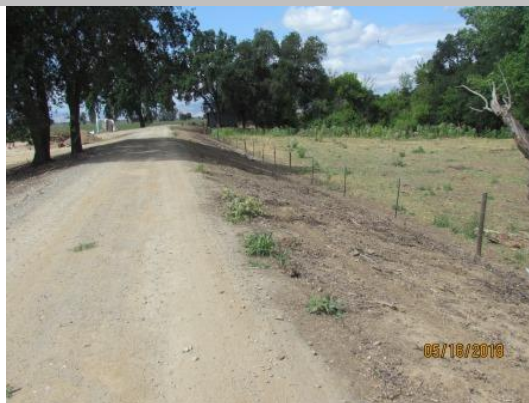
Photo 1 of 1 : SP_2018_RD2031_307_54_20180517_00112.jpg

LM Start	2.09	Rating **	A	Issue No.	54
LM End	7.07	Issue Type +	Ma	Location *	WS
Category	Earthen Levee			GPS Latitude/Longitude	
				Start	End
Item	Vegetation			37.692493 °	37.661853 °
				-121.177688 °	-121.232864 °
DWR ID	DWR_RD2031_01_s_2018_54				
Comment Code					
V1 : Control annual grass and weeds on the levee slopes and easements.					
Inspector Comment					
The annual vegetation through this section is well maintained, Spring 2018.

View looking downstream waterside of the well maintained annual vegetation, Spring 2018.

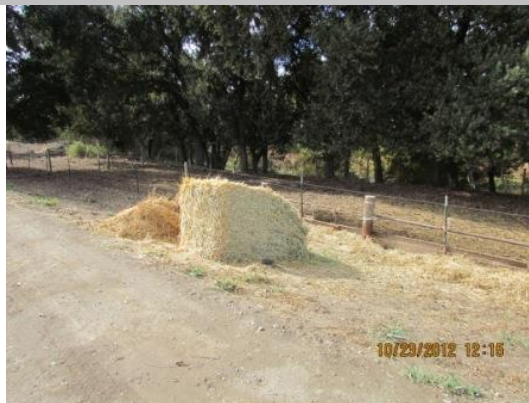
Photo 1 of 1 : SP_2018_RD2031_307_39_20180515_00021.jpg

LM Start	2.15	Rating **	M	Issue No.	39
LM End	2.15	Issue Type +	En	Location *	WS
Category	Earthen Levee			GPS Latitude/Longitude	
				Start	End
Item	Encroachments			37.691687 °	37.691687 °
				-121.178285 °	-121.178285 °
DWR ID	DWR_RD2031_01_f_2012_39				
Comment Code					
CR : Crops					
Inspector Comment					
Hay bale on waterside levee slope.

View of hay bales at toe of levee on waterward side, facing downstream.
05/02/2012

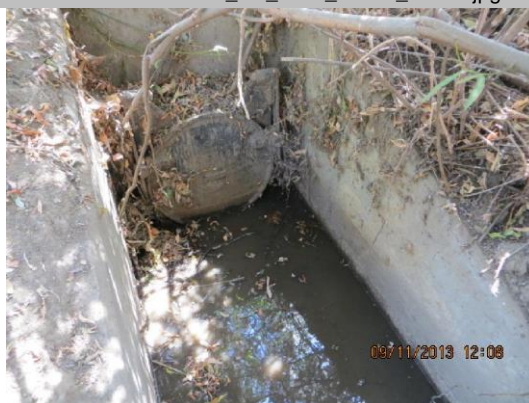
Photo 1 of 3 : UCIP_SP_2018_20110_34078.jpg

LM Start	2.39	Rating **	A/W	Issue No.	994
LM End	2.39	Issue Type +	Ma	Location *	
Category	Supplemental			GPS Latitude/Longitude	
				Start	End
Item	DWR UCIP LMA Responsibility			37.688676 °	37.688676 °
				-121.179622 °	-121.179622 °
DWR ID					
Comment Code					
Inspector Comment					
FS_ID:20110 DS_ID:20449 EP_NO: N/A Repair Type: No Action Needed Crossing Status: Found UCIP Comments: FIELD_STRUCT_DESC: 24-inch corrugated metal drainage pipe through the levee, 3 feet below the crown. Concrete U-shaped headwall on the waterside (WS) end. Flap gate on the WS end. 5-foot by 5-foot concrete riser with pump on the LS toe. Likely that concrete riser is inlet for drainage pipe. [Additional Reference(s): DWR Levee Log, 2005. USACE San Joaquin O&M Manual 4, June 1968, (HLM 2.41)]. FS Date: 9/11/2013

Flapgate and concrete headwall on WS toe.

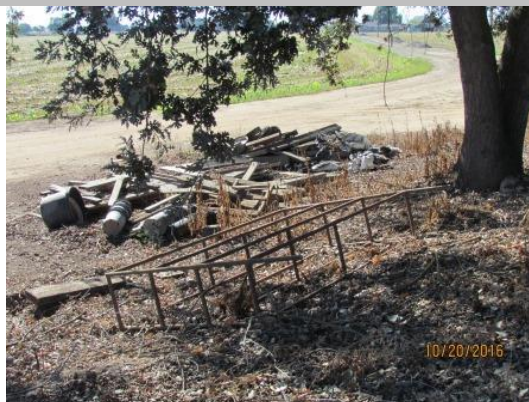
Photo 1 of 2 : SP_2018_RD2031_307_53_20180515_00031.jpg

LM Start	2.40	Rating **	M	Issue No.	53
LM End	2.44	Issue Type +	En	Location *	LS
Category	Earthen Levee			GPS Latitude/Longitude	
				Start	End
Item	Encroachments			37.688465 °	37.688064 °
				-121.179821 °	-121.180175 °
DWR ID	DWR_RD2031_01_s_2015_53				
Comment Code					
DE : Debris					
Inspector Comment

View of the debris at the landside levee toe.

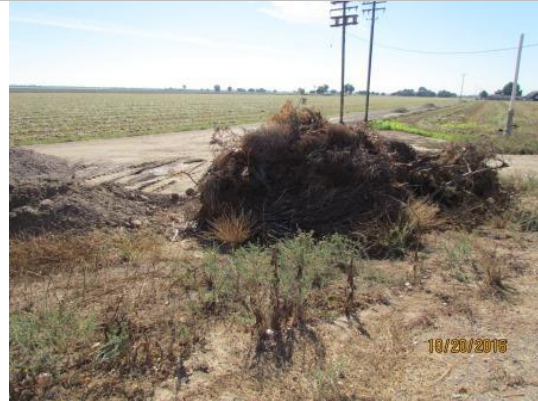
Photo 2 of 2 : SP_2018_RD2031_307_53_20180515_00032.jpg

LM Start	2.40	Rating **	M	Issue No.	53 (cont)	
LM End	2.44	Issue Type +	En	Location *	LS	
Category	Earthen Levee			GPS Latitude/Longitude		
				Start	End	
Item	Encroachments			37.688465 °	37.688064 °	
				-121.179821 °	-121.180175 °	
DWR ID	DWR_RD2031_01_s_2015_53					
Comment Code						
DE : Debris						
Inspector Comment

View of another debris pile in close proximity of the previous photo.

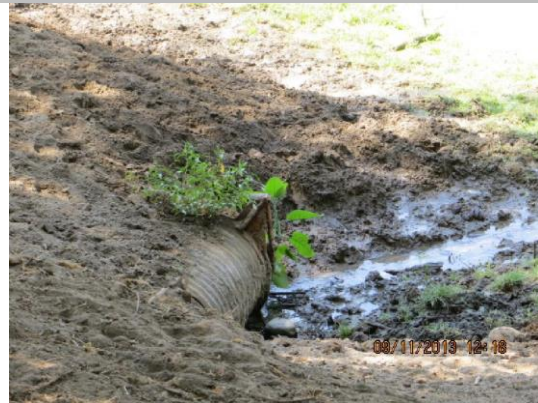
Photo 1 of 3 : UCIP_SP_2018_51340_39002.jpg

Comment Code					
Inspector Comment					
FS_ID:51340 DS_ID:24669 EP_NO: N/A Repair Type: Non-Urgent Crossing Status: Found UCIP Comments: 11/16/2016 No access to WS due to cattle fence in place. Need to coordinate with property owner to obtain access on WS. Unable to find inlet on LS. Reomend internal inspection of crossing. Crossing has been downgraded from Urgent to Non-Urgent no signs of leaks where present on crown or slopes where pipe should be. (O. Magana - DWR UCIP)09/11/2013 Flapgate partially blocked by soil on WS toe. Good candidate for video inspection. (W. Wylie - DWR UCIP) FIELD_STRUCT_DESC: 24-inch corrugated metal drainage pipe through the levee, at an unknown depth. Flap gate on the waterside (WS) toe. Pipe may originate at a concrete distribution box on the landside (LS) toe. FS Date: 11/16/2016

Flapgate and pipe visible on WS toe.

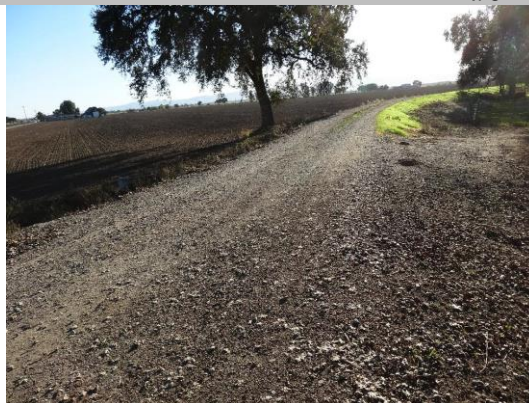
Photo 2 of 3 : UCIP_SP_2018_51340_76567.jpg

Comment Code						
Inspector Comment						
FS_ID:51340 DS_ID:24669 EP_NO: N/A Repair Type: Non-Urgent Crossing Status: Found UCIP Comments: 11/16/2016 No access to WS due to cattle fence in place. Need to coordinate with property owner to obtain access on WS. Unable to find inlet on LS. Reomend internal inspection of crossing. Crossing has been downgraded from Urgent to Non-Urgent no signs of leaks where present on crown or slopes where pipe should be. (O. Magana - DWR UCIP)09/11/2013 Flapgate partially blocked by soil on WS toe. Good candidate for video inspection. (W. Wylie - DWR UCIP) FIELD_STRUCT_DESC: 24-inch corrugated metal drainage pipe through the levee, at an unknown depth. Flap gate on the waterside (WS) toe. Pipe may originate at a concrete distribution box on the landside (LS) toe. FS Date: 11/16/2016

Overview of levee crown where pipe should cross levee. Limited access on WS due to fence.

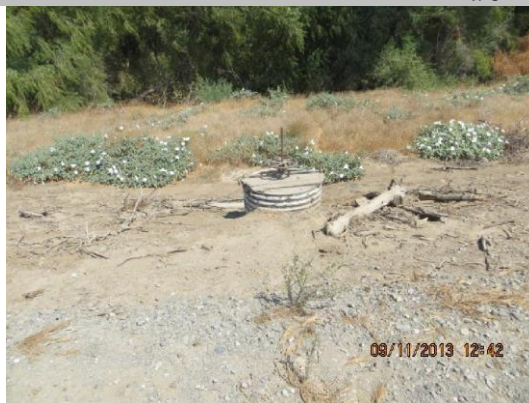
Photo 1 of 3 : UCIP_SP_2018_20449_34506.jpg

LM Start	3.08	Rating **	M	Issue No.	996	
LM End	3.08	Issue Type +	Ma	Location *		
Category	Supplemental			GPS Latitude/Longitude		
				Start	End	
Item	DWR UCIP LMA Responsibility			37.688297 °	37.688297 °	
				-121.190865 °	-121.190865 °	
DWR ID						
Comment Code						
Inspector Comment						
FS_ID:20449						
DS_ID:20451						
EP_NO: N/A						
Repair Type: Non-Urgent						
Crossing Status: Found						
UCIP Comments: Pipe appears to be abandoned and if so should be done so properly.						
FIELD_STRUCT_DESC: *ABANDONED* 24-inch corrugated metal drainage pipe through the levee, 14 feet below the crown. Slide gate in a 36-inch corrugated metal pipe (CMP) riser on the waterside (WS) slope. [Additional Reference(s): DWR Levee Log, 2005. USACE San Joaquin O&M Manual 4, June 1968, (HLM 3.11)].						
FS Date: 9/11/2013

Slide gate in CMP riser on WS slope.

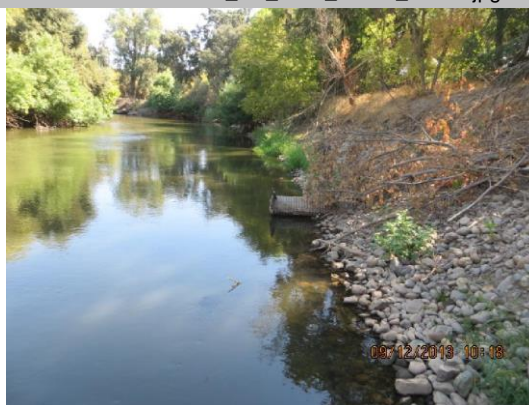
Photo 1 of 2 : UCIP_SP_2018_23064_39200.jpg

LM Start	3.66	Rating **	M	Issue No.	997	
LM End	3.66	Issue Type +	Ma	Location *		
Category	Supplemental			GPS Latitude/Longitude		
				Start	End	
Item	DWR UCIP LMA Responsibility			37.689900 °	37.689900 °	
				-121.198319 °	-121.198319 °	
DWR ID						
Comment Code						
Inspector Comment						
FS_ID:23064						
DS_ID:20478						
EP_NO: N/A						
Repair Type: Non-Urgent						
Crossing Status: Found						
UCIP Comments: Good candidate for video inspection.						
FIELD_STRUCT_DESC: 24-inch corrugated metal drainage pipe through the levee, 5.5 feet below the crown. Flap gate visible at the waterside (WS) toe. [Additional Reference(s): USACE San Joaquin O&M Manual 4, June 1968, (HLM 3.7), listed as a 20-inch pipe, 3.9 feet below the crown].						
FS Date: 9/12/2013

CMP pipe and flapgate visible at WS toe.

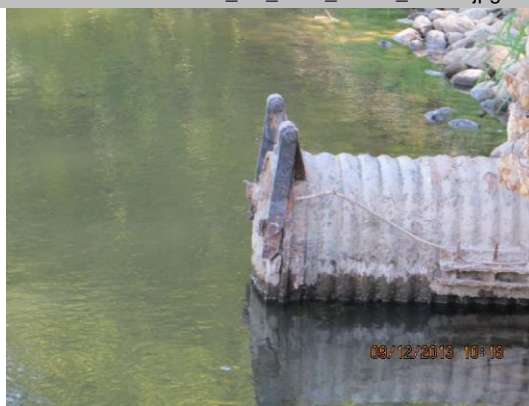
Photo 2 of 2 : UCIP_SP_2018_23064_39199.jpg

LM Start	3.66	Rating **	M	Issue No.	997 (cont)	
LM End	3.66	Issue Type +	Ma	Location *		
Category	Supplemental			GPS Latitude/Longitude		
				Start	End	
Item	DWR UCIP LMA Responsibility			37.689900 °	37.689900 °	
				-121.198319 °	-121.198319 °	
DWR ID						
Comment Code						
Inspector Comment						
FS_ID:23064						
DS_ID:20478						
EP_NO: N/A						
Repair Type: Non-Urgent						
Crossing Status: Found						
UCIP Comments: Good candidate for video inspection.						
FIELD_STRUCT_DESC: 24-inch corrugated metal drainage pipe through the levee, 5.5 feet below the crown. Flap gate visible at the waterside (WS) toe. [Additional Reference(s): USACE San Joaquin O&M Manual 4, June 1968, (HLM 3.7), listed as a 20-inch pipe, 3.9 feet below the crown].						
FS Date: 9/12/2013

CMP pipe and flapgate visible at WS toe.

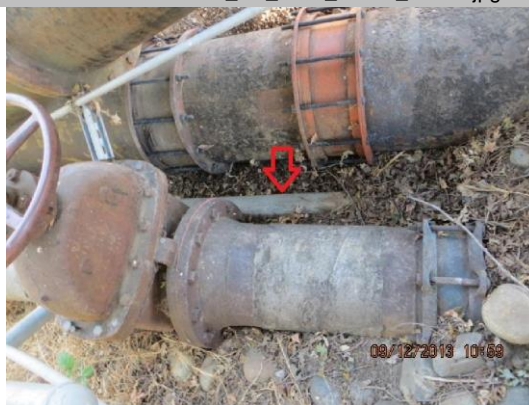
Photo 1 of 2 : UCIP_SP_2018_22843_39015.jpg

LM Start	3.69	Rating **	M	Issue No.	998
LM End	3.69	Issue Type +	En	Location *	
Category	Supplemental			GPS Latitude/Longitude	
				Start	End
Item	DWR UCIP Field Study			37.689742 °	37.689742 °
				-121.198778 °	-121.198778 °
DWR ID					
Comment Code					
Inspector Comment					
FS_ID:22843 DS_ID:24672 EP_NO: N/A Repair Type: Non-Urgent Crossing Status: Found UCIP Comments: No permit identified for this possible crossing. FIELD_STRUCT_DESC: 4-inch steel irrigation pipe through the levee, at an unknown depth. Pipe visible between larger irrigation pipes below slant pump on the waterside (WS) slope. FS Date: 9/12/2013

Pipe visible between larger irrigation pipes below slant pump on WS slope.

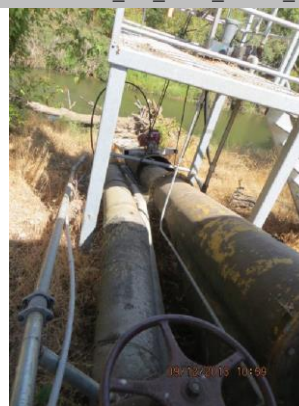
Photo 2 of 2 : UCIP_SP_2018_22843_39014.jpg

LM Start	3.69	Rating **	M	Issue No.	998 (cont)
LM End	3.69	Issue Type +	En	Location *	
Category	Supplemental			GPS Latitude/Longitude	
				Start	End
Item	DWR UCIP Field Study			37.689742 °	37.689742 °
				-121.198778 °	-121.198778 °
DWR ID					
Comment Code					
Inspector Comment					
FS_ID:22843 DS_ID:24672 EP_NO: N/A Repair Type: Non-Urgent Crossing Status: Found UCIP Comments: No permit identified for this possible crossing. FIELD_STRUCT_DESC: 4-inch steel irrigation pipe through the levee, at an unknown depth. Pipe visible between larger irrigation pipes below slant pump on the waterside (WS) slope. FS Date: 9/12/2013

Pipe visible between larger irrigation pipes below slant pump on WS slope.

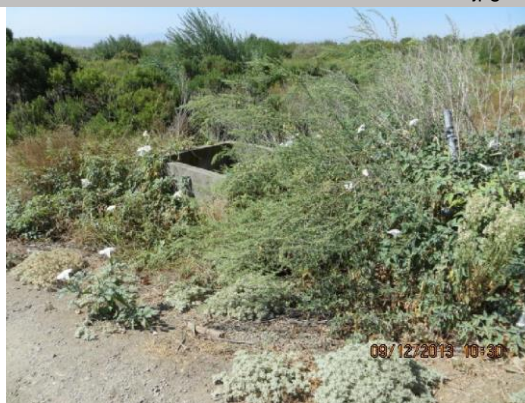
Photo 1 of 3 : UCIP_SP_2018_20667_34750.jpg

Comment Code					
Inspector Comment					
FS_ID:20667					
DS_ID:20456					
EP_NO: N/A					
Repair Type: Non-Urgent					
Crossing Status: Found					
UCIP Comments: Siphon breaker missing from LS shoulder. Fish screen and pipe end covered in debris that may cause damage to pipe.					
FIELD_STRUCT_DESC: 1 of 2: 20-inch steel irrigation pipe through the levee, 3.9 feet below the crown. Slant pump in pump house mounted on piles on the berm. Siphon breaker in a corrugated metal pipe (CMP) riser on the landside (LS) shoulder. Service pole on the LS slope. 5-foot by 5-foot concrete distribution box on the LS toe with flap gate.					
[Additional Reference(s): DWR Levee Log, 2005. USACE San Joaquin O&M Manual 4, June 1968, (HLM 3.70)].					
FS Date: 9/12/2013

Concrete distribution box on LS slope.

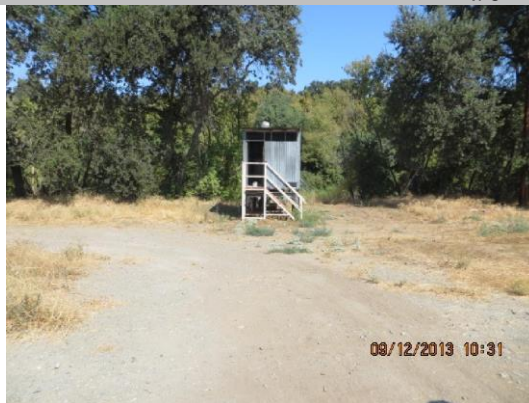
Photo 1 of 3 : UCIP_SP_2018_22845_39021.jpg

LM Start	3.69	Rating **	M	Issue No.	1000
LM End	3.69	Issue Type +	En	Location *	
Category	Supplemental			GPS Latitude/Longitude	
				Start	End
Item	DWR UCIP Field Study			37.689757 °	37.689757 °
				-121.198804 °	-121.198804 °
DWR ID					
Comment Code					
Inspector Comment					
FS_ID:22845 DS_ID:24671 EP_NO: N/A Repair Type: Non-Urgent Crossing Status: Found UCIP Comments: No permit identified for this possible crossing. FIELD_STRUCT_DESC: 2.5-inch galvanized iron irrigation pipe through the levee, at an unknown depth. Submersible pump on the waterside (WS) slope. FS Date: 9/12/2013

Pipe visible on WS of pumphouse.

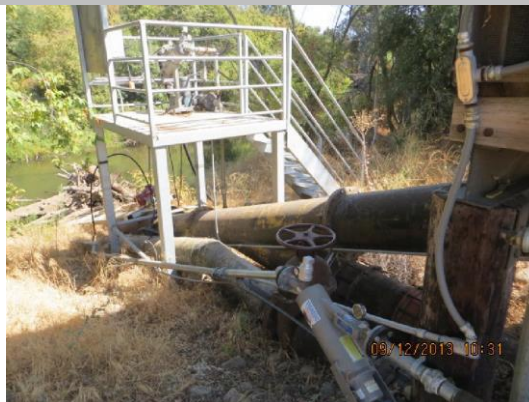
Photo 2 of 3 : UCIP_SP_2018_22845_39020.jpg

Pipe and appurtenances visible on downstream side of and next to larger irrigation pipe.

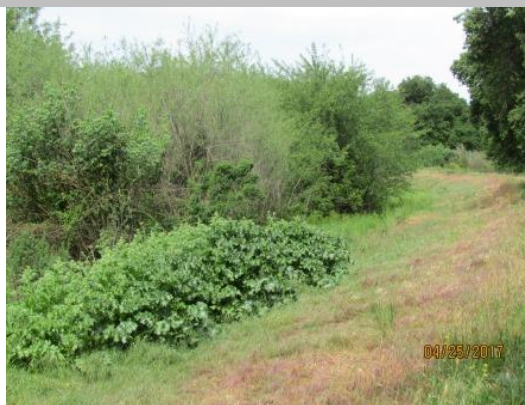
Photo 1 of 4 : SP_2018_RD2031_307_33_20180515_00014.jpg

LM Start	3.69	Rating **	U	Issue No.	33
LM End	4.24	Issue Type +	Ma	Location *	LS
Category	Earthen Levee			GPS Latitude/Longitude	
				Start	End
Item	Vegetation			37.689718 °	37.687811 °
				-121.198833 °	-121.205659 °
DWR ID	DWR_RD2031_01_f_2016_33				
Comment Code					
V2 : Remove the wild growth other than native grasses from the levee slopes.					
Inspector Comment					
Trim back woody vegetation at least 15 feet away from the landside levee toe.

View of the vegetation at the levee toe and slope.

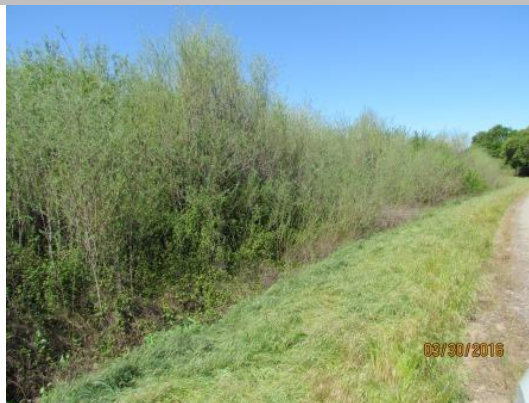
Photo 2 of 4 : SP_2018_RD2031_307_33_20180515_00015.jpg

Typical view of the tall vegetation on the landside levee slope and toe in this area.

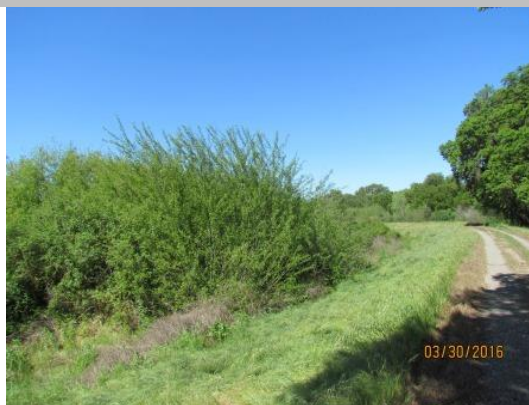
Photo 3 of 4 : SP_2018_RD2031_307_33_20180515_00016.jpg

View of the tall vegetation on the landside levee slope and toe.

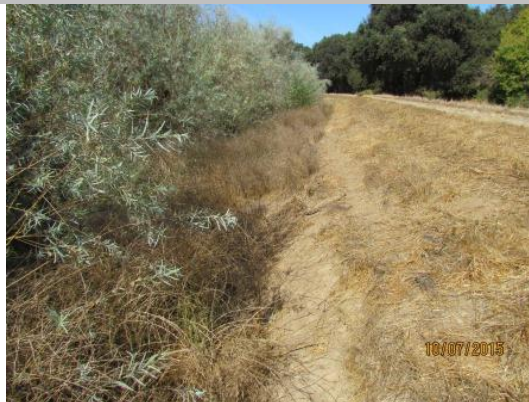
Photo 1 of 1 : SP_2018_RD2031_307_57_20180515_00034.jpg

LM Start	3.78	Rating **	M	Issue No.	57
LM End	3.81	Issue Type +	Ma	Location *	LS
Category	Earthen Levee			GPS Latitude/Longitude	
				Start	End
Item	Erosion / Bank Caving			37.690302 °	37.690664 °
				-121.200232 °	-121.200549 °
DWR ID	DWR_RD2031_01_f_2015_57				
Comment Code					
E2 : Schedule repair of erosion site prior to the next inspection.					
Inspector Comment					
Erosion at the landside levee toe.

View of the 18 inch vertical cut at the landside levee toe.

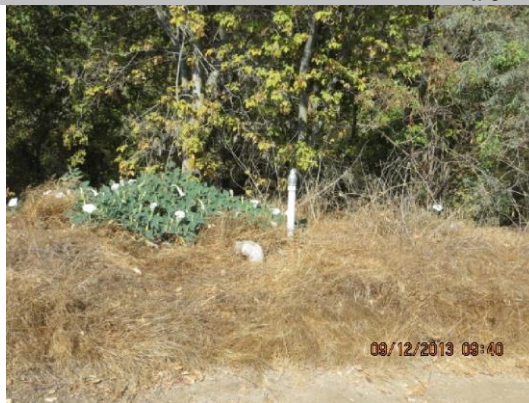
Photo 1 of 2 : UCIP_SP_2018_22846_39023.jpg

LM Start	4.40	Rating **	M	Issue No.	1001
LM End	4.40	Issue Type +	En	Location *	
Category	Supplemental			GPS Latitude/Longitude	
				Start	End
Item	DWR UCIP Field Study			37.686500 °	37.686500 °
				-121.207900 °	-121.207900 °
DWR ID					
Comment Code					
Inspector Comment					
FS_ID:22846 DS_ID:24673 EP_NO: N/A Repair Type: Non-Urgent Crossing Status: Found UCIP Comments: No permit identified for this possible crossing. FIELD_STRUCT_DESC: 4-inch galvanized iron irrigation pipe visible on the waterside (WS) shoulder. Pipe may go through the levee, at an unknown depth. Vent on the WS shoulder. FS Date: 9/12/2013

Pipe and vent visible on WS shoulder.

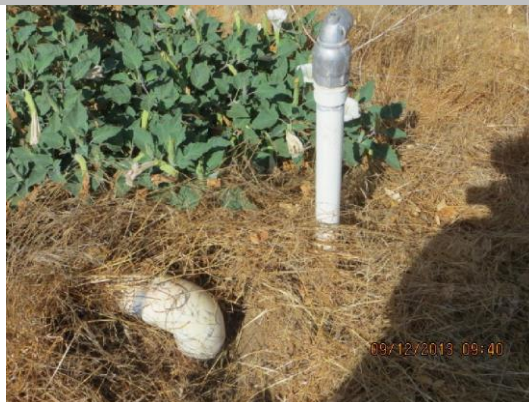
Photo 2 of 2 : UCIP_SP_2018_22846_39022.jpg

Pipe and vent visible on WS shoulder.

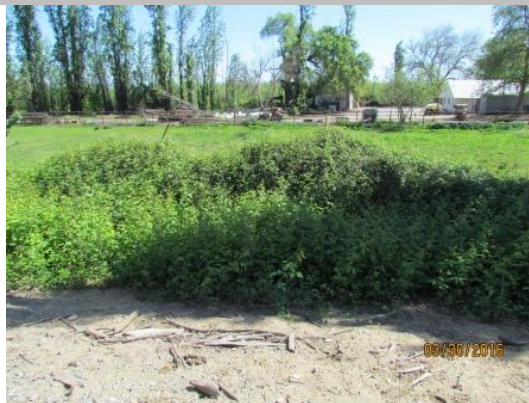
Photo 1 of 1 : SP_2018_RD2031_307_43_20180515_00024.jpg

LM Start	4.52	Rating **	U	Issue No.	43
LM End	4.52	Issue Type +	Ma	Location *	LS
Category	Earthen Levee			GPS Latitude/Longitude	
				Start	End
Item	Vegetation			37.684988 °	37.684988 °
				-121.208366 °	-121.208366 °
DWR ID	DWR_RD2031_01_s_2016_43				
Comment Code					
V2 : Remove the wild growth other than native grasses from the levee slopes.					
Inspector Comment

View of the tall vegetation on the landside levee slope and toe.

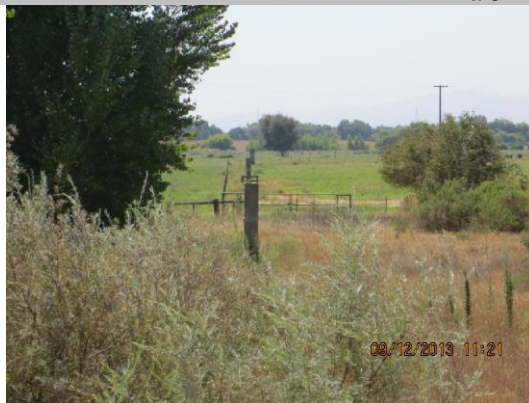
Photo 1 of 2 : UCIP_SP_2018_20688_34799.jpg

Comment Code						
Inspector Comment						
FS_ID:20688 DS_ID:20461 EP_NO: N/A Repair Type: Non-Urgent Crossing Status: Found UCIP Comments: CMP riser on WS slope is missing lid and may be a hazard. FIELD_STRUCT_DESC: 36-inch corrugated metal irrigation pipe through the levee, 11 feet below the crown. Slide gate in a 48-inch corrugated metal pipe (CMP) riser on the waterside (WS) slope. 5-foot by 5-foot concrete distribution box, 10 feet from the WS toe. Underground irrigation system on the landside (LS) with concrete standpipes visible in field. [Additional Reference(s): DWR Levee Log, 2005. USACE San Joaquin O&M Manual 4, June 1968, (HLM 5.02)]. FS Date: 9/12/2013

Concrete standpipes visible in field off LS toe.

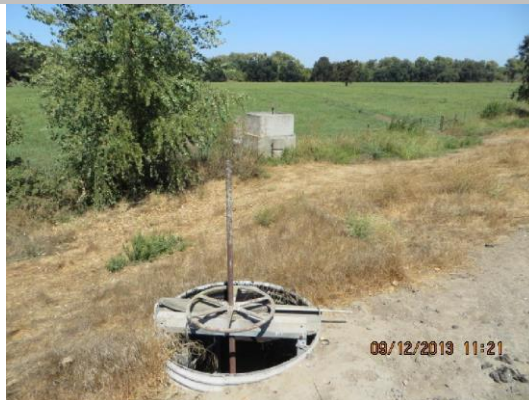
Photo 2 of 2 : UCIP_SP_2018_20688_34798.jpg

Slide gate in CMP riser on WS shoulder with concrete distribution box visible in background at WS toe.

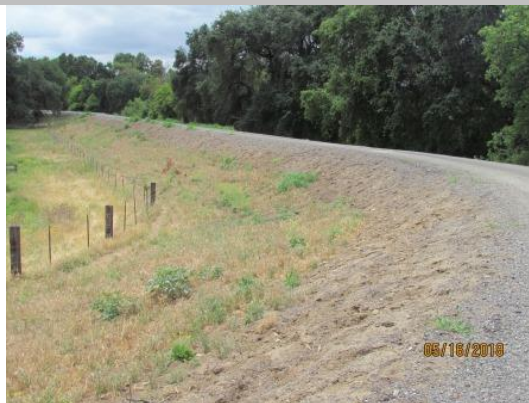
Photo 1 of 1 : SP_2018_RD2031_308_15_20180517_00049.jpg

LM Start	0.00	Rating **	A	Issue No.	15
LM End	5.97	Issue Type +	Ma	Location *	LS
Category	Earthen Levee			GPS Latitude/Longitude	
				Start	End
Item	Vegetation			37.661853 °	37.630765 °
				-121.232862 °	-121.159189 °
DWR ID	DWR_RD2031_02_s_2018_15				
Comment Code					
V1 : Control annual grass and weeds on the levee slopes and easements.					
Inspector Comment					
Annual vegetation is well maintained, Spring 2018.

View looking downstream landside of the well maintained annual vegetation.

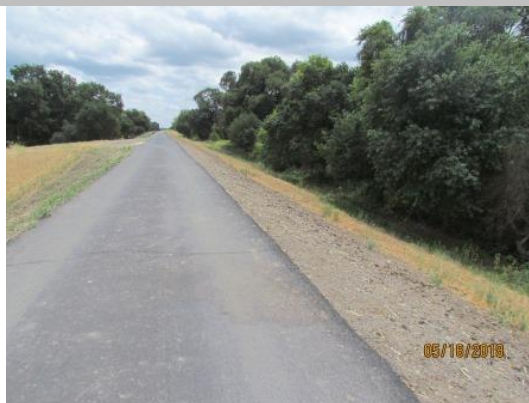
Photo 1 of 1 : SP_2018_RD2031_308_16_20180517_00048.jpg

LM Start	0.00	Rating **	A	Issue No.	16	
LM End	5.97	Issue Type +	Ma	Location *	WS	
Category	Earthen Levee			GPS Latitude/Longitude		
				Start		End
Item	Vegetation			37.661853 °		37.630765 °
				-121.232863 °		-121.159189 °
DWR ID	DWR_RD2031_02_s_2018_16					
Comment Code						
V1 : Control annual grass and weeds on the levee slopes and easements.						
Inspector Comment						
Annual vegetation is well maintained, Spring 2018.

View looking downstream waterside of the well maintained annual vegetation.

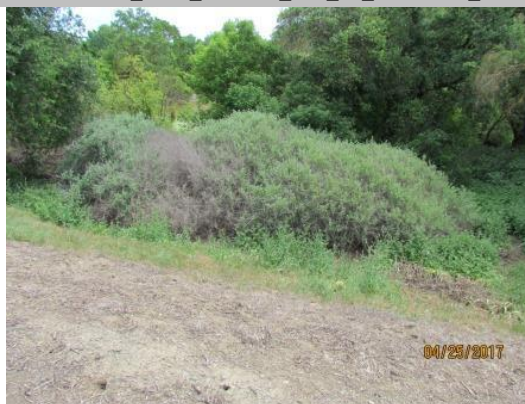
Photo 1 of 1 : SP_2018_RD2031_308_20_20180515_00007.jpg

LM Start	0.18	Rating **	U	Issue No.	20
LM End	0.18	Issue Type +	Ma	Location *	LS
Category	Earthen Levee			GPS Latitude/Longitude	
				Start	End
Item	Vegetation			37.659394 °	37.659394 °
				-121.234020 °	-121.234020 °
DWR ID	DWR_RD2031_02_s_2017_20				
Comment Code					
V2 : Remove the wild growth other than native grasses from the levee slopes.					
Inspector Comment					
Remove shrubs from levee toe to allow visibility and access.

View of the dense shrubs at the levee toe.

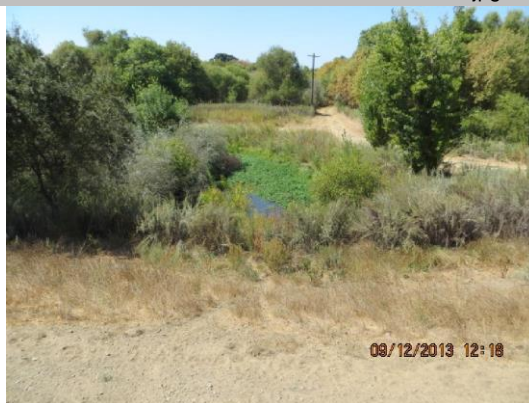
Photo 2 of 3 : UCIP_SP_2018_20703_34821.jpg

Pond at outlet on WS toe.

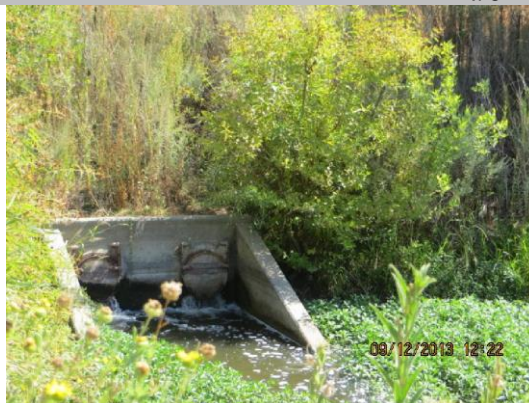
Photo 3 of 3 : UCIP_SP_2018_20703_34820.jpg

Concrete U-shaped headwall with flapgate on WS toe.

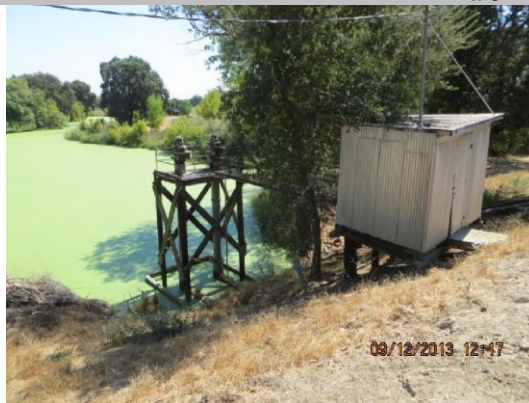
Photo 1 of 3 : UCIP_SP_2018_20704_34826.jpg

Pump on pier on LS toe with shed at pump walkway.
